**Flood Control Project Maintenance
Levee Inspections**
LMA District Cover Sheet
Spring 2018 Levee Inspection Results

Reclamation District No. 2091 Chase

Spring 2018 Levee Inspection Results

Waterway			Bank	Unit Miles
Unit No. 01 San Joaquin River			Right	7.46
	Spring (March - May)	Summer (June - August)	(September - November) Fall	Winter (December - February)
Unit Maintenance Rating (Fall Only)				
Date of Inspection	5/1/2018 - 5/1/2018			
DWR Inspector	Richard Willoughby			
Accompanied By

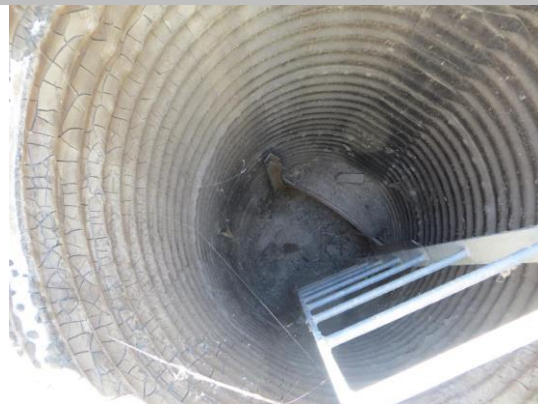
Photo 2 of 3 : UCIP_SP_2018_51387_38149.jpg

Slide gate missing from open end of pipe at WS slope.

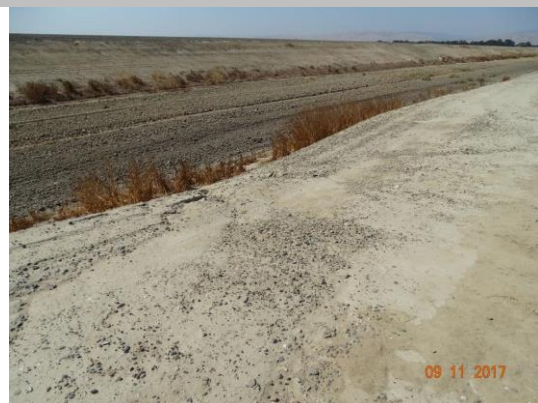
Photo 1 of 2 : SP_2018_RD2091_318_15_20180307_00015.jpg

LM Start	0.23	Rating **	M	Issue No.	15
LM End	0.23	Issue Type +	Ma	Location *	LS
Category	Earthen Levee			GPS Latitude/Longitude	
				Start	End
Item	Erosion / Bank Caving			37.541550 °	37.541550 °
				-121.096742 °	-121.096742 °
DWR ID	DWR_RD2091_01_s_2016_15				
Comment Code					
E1 : Note and monitor erosion site.					
Inspector Comment					
Caving on landward shoulder possible collapsed pipe. Caving is 34 feet long over one inch depth.

Looking southwest at the dip on the landside shoulder.

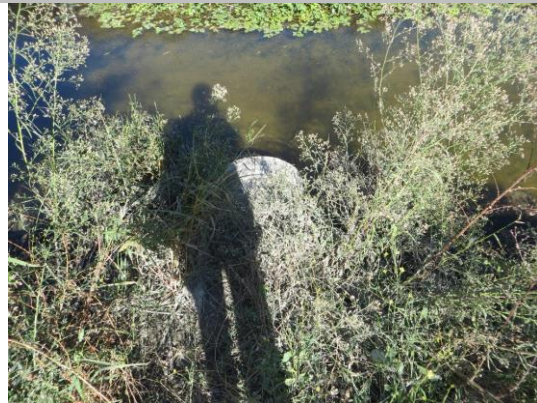
Photo 1 of 3 : UCIP_SP_2018_51388_38156.jpg

Comment Code					
Inspector Comment					
FS_ID:51388 DS_ID:23158 EP_NO: N/A Repair Type: Urgent Crossing Status: Found UCIP Comments: 11/18/2016 Same as last inspection. This crossing remains Urgent due to the flap gate still missing from the WS toe. According to Mike A. this crossing is an abandoned line and the City of Modesto is working with CVFPB to authorize proper abandonment/removal. The City is working at finding funds to pay for proper abandonment/removal of all the drainage structures through this levee. (O. Magana - DWR UCIP)01/29/2015 Flap gate has fallen off at WS toe. Appears abandoned and if so should be done so properly. (M. Alves - City of Modesto) FIELD_STRUCT_DESC: *ABANDONED* 24-inch corrugated metal drainage pipe through the levee, 10 feet below the crown. Flap gate on the waterside (WS) end. Drain opening is located approximately 15 feet off the landside (LS) toe. [Additional Reference(s): DWR Levee Log, 1992. USACE San Joaquin O&M Manual 6, September 1961, (HLM 0.23), Drawing No. 07-04-1555, Sheets 1555/17 and 1555/55, (Station 915+00)]. FS Date: 11/18/2016

Pipe visible in canal on WS toe.

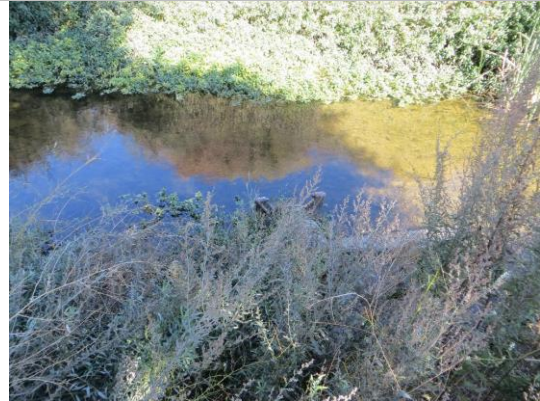
Photo 1 of 3 : UCIP_SP_2018_51639_38158.jpg

FS_ID:51639
DS_ID:23161
EP_NO: N/A
Repair Type: Non-Urgent
Crossing Status: Found
UCIP Comments: 11/18/2016 Crossing has been downgraded from Urgent to Non-Urgent since the flap gate appears to fully close. According to Mike Alvez, this crossing is abandoned and the City of Modesto is working with CVFPB to authorize proper abandonment/removal. The City is working at finding funds to pay for proper abandonment/removal of all the drainage structures through this levee. (O. Magana - DWR UCIP)01/29/2015 Appears abandoned and if so should be done so properly. (M. Alvez - City of Modesto)
FIELD_STRUCT_DESC: *ABANDONED* 24-inch corrugated metal drainage pipe through the levee, 12 feet below the crown. Flap gate and concrete headwall on the waterside (WS) end. [Additional Reference(s): DWR Levee Log, 1992. USACE San Joaquin O&M Manual 6, September 1961, (HLM 0.64)].
FS Date: 11/18/2016

24-inch CMP on concrete headwall with flapgate on WS toe.

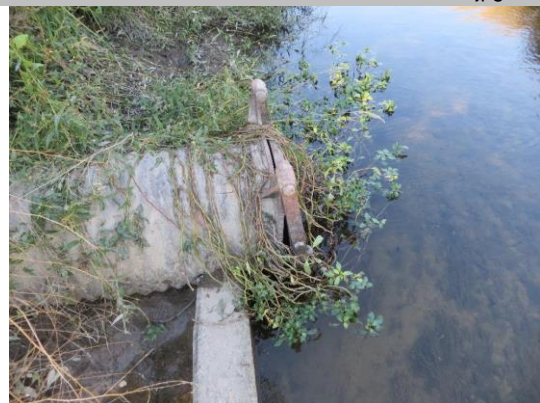
Photo 2 of 3 : UCIP_SP_2018_51639_38157.jpg

24-inch CMP on concrete headwall with flapgate on WS toe.

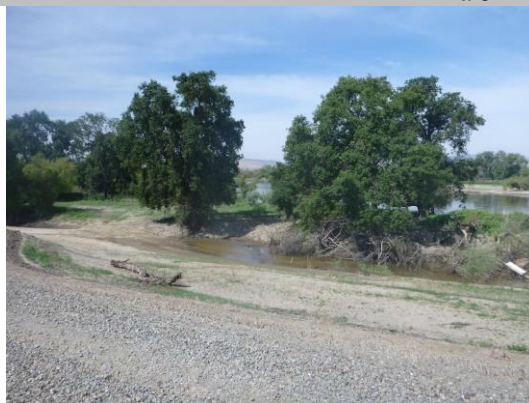
Photo 1 of 3 : LEVAL_SP_2018_132_1181.jpg

LM Start	1.41	Rating **	A/W	Issue No.	24
LM End	1.44	Issue Type +	Ma	Location *	
Category	Supplemental			GPS Latitude/Longitude	
				Start	End
Item	2017 Storm Damage			37.531170 °	37.530760 °
				-121.106750 °	-121.106710 °
DWR ID	DWR_RD2091_01_f_2017_24				
Comment Code					
Inspector Comment					
Levee Evaluation Comments					
Description:					
Site ID No:132					
Site Designation:DWR_RD2091_01_R_2012_01					
Repair Type: Erosion					
Rating:Area of Concern					
Field Date:6/7/2017					
Notes: Wavewash erosion up to 12" deep at high water mark.

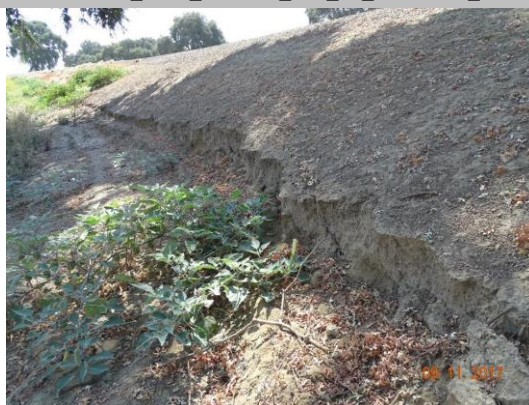
Photo 1 of 1 : SP_2018_RD2091_318_18_20180307_00020.jpg

LM Start	2.05	Rating **	M	Issue No.	18
LM End	2.06	Issue Type +	Ma	Location *	LS
Category	Earthen Levee			GPS Latitude/Longitude	
				Start	End
Item	Erosion / Bank Caving			37.526083 °	37.525897 °
				-121.099328 °	-121.099116 °
DWR ID	DWR_RD2091_01_f_2017_18				
Comment Code					
E2 : Schedule repair of erosion site prior to the next inspection.					
Inspector Comment					
Erosion at the landside toe.

Looking southeast at erosion on the toe of the landside slope.

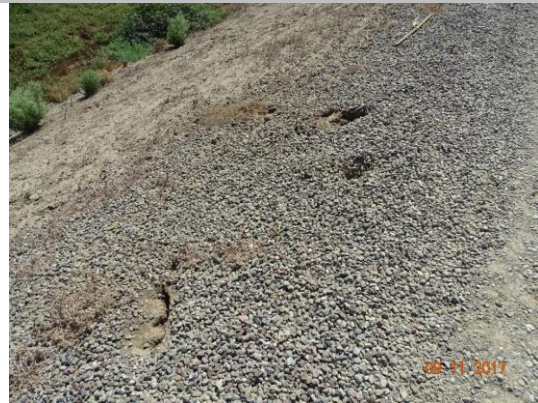
Photo 1 of 1 : SP_2018_RD2091_318_30_20180307_00030.jpg

LM Start	3.90	Rating **	C	Issue No.	21
LM End	3.90	Issue Type +	Ma	Location *	LS
Category	Earthen Levee			GPS Latitude/Longitude	
				Start	End
Item	Erosion / Bank Caving			37.506902 °	37.506902 °
				-121.082771 °	-121.082771 °
DWR ID	DWR_RD2091_01_s_2017_21				
Comment Code					
E2 : Schedule repair of erosion site prior to the next inspection.					
Inspector Comment					
Sinkhole at landward side toe

Looking south at landside slope.

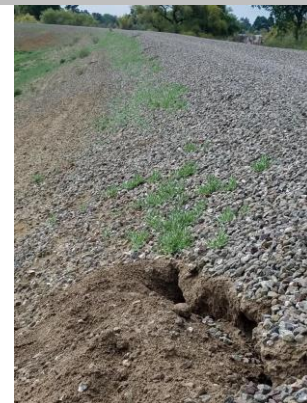
Photo 1 of 1 : SP_2018_RD2091_318_22_20180307_00023.jpg

LM Start	4.25	Rating **	M	Issue No.	22
LM End	4.25	Issue Type +	Ma	Location *	LS
Category	Earthen Levee			GPS Latitude/Longitude	
				Start	End
Item	Animal Control			37.501907 °	37.501907 °
				-121.082123 °	-121.082123 °
DWR ID	DWR_RD2091_01_s_2017_22				
Comment Code					
A3 : No rodents visible, but rodent burrows visible; need to backfill and compact or grout burrows.					
Inspector Comment

Looking south at rodent activity on landward shoulder and slope.

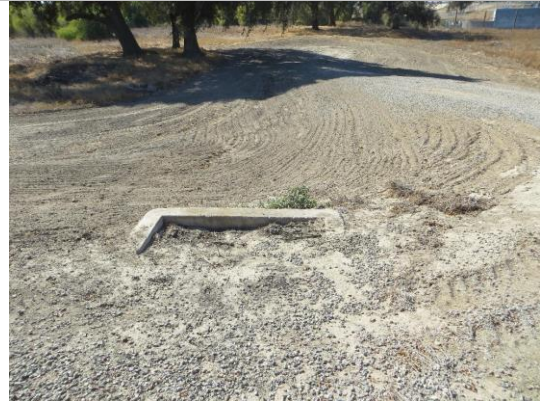
Photo 3 of 3 : UCIP_SP_2018_43209_38209.jpg

LM Start	4.59	Rating **	M	Issue No.	49 (cont)
LM End	4.59	Issue Type +	En	Location *	
Category	Supplemental			GPS Latitude/Longitude	
				Start	End
Item	DWR UCIP Field Study			37.497390 °	37.497390 °
				-121.080370 °	-121.080370 °
DWR ID					
Comment Code					
Inspector Comment					
FS_ID:43209 DS_ID:23165 EP_NO: N/A Repair Type: Non-Urgent Crossing Status: Found UCIP Comments: Appears abandoned and if so should be done so properly. FIELD_STRUCT_DESC: 36-inch corrugated metal irrigation pipe through the levee, 15 feet below the crown. Abandoned concrete inlet box on the waterside (WS) slope of the levee. 6-foot by 5-foot concrete distribution box at the landside (LS) toe. [Additional Reference(s): DWR Levee Log, 1992. USACE San Joaquin O&M Manual 6, September 1961, (HLM 4.67), 30-inch pipe listed]. FS Date: 1/29/2015 2:27:42 PM

Abandoned concrete box on WS slope.

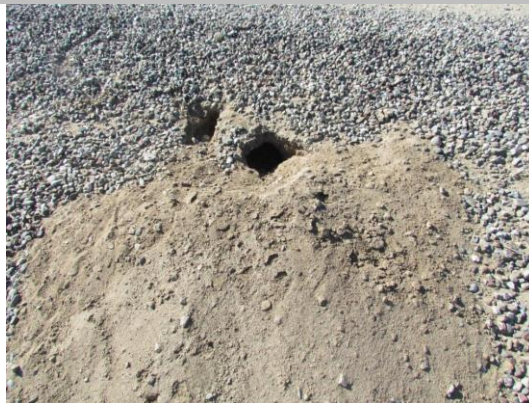
Photo 4 of 4 : SP_2018_RD2091_318_10_20180307_00006.jpg

Looking west at close-up view of rodent holes on landward slope.

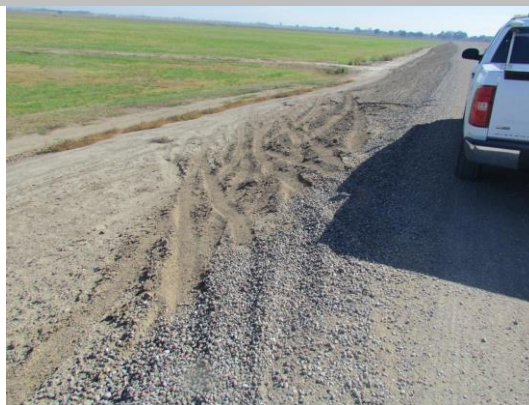
Photo 2 of 2 : SP_2018_RD2091_318_13_20180307_00011.jpg

Looking at damage on landside slope.

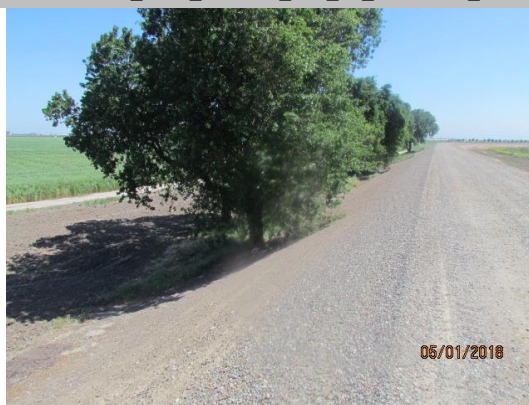
Photo 1 of 1 : SP_2018_RD2091_318_12_20180503_00050.jpg

Looking southeast at untrimmed tree at landward toe. (Spring 2018)

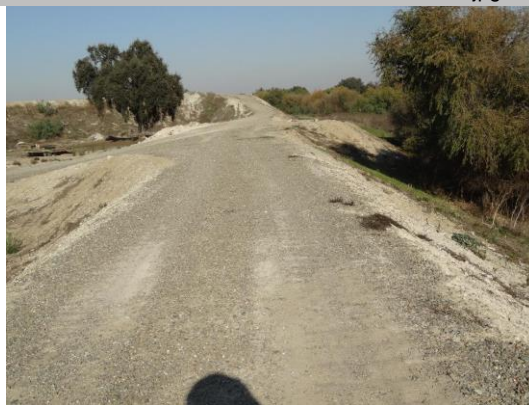
Photo 2 of 3 : UCIP_SP_2018_51390_76689.jpg

Overview photo of levee crown at crossing.
